Intel® Pentium® III Processor Specification Update

Release Date: June 2002

Order Number: 244453-042

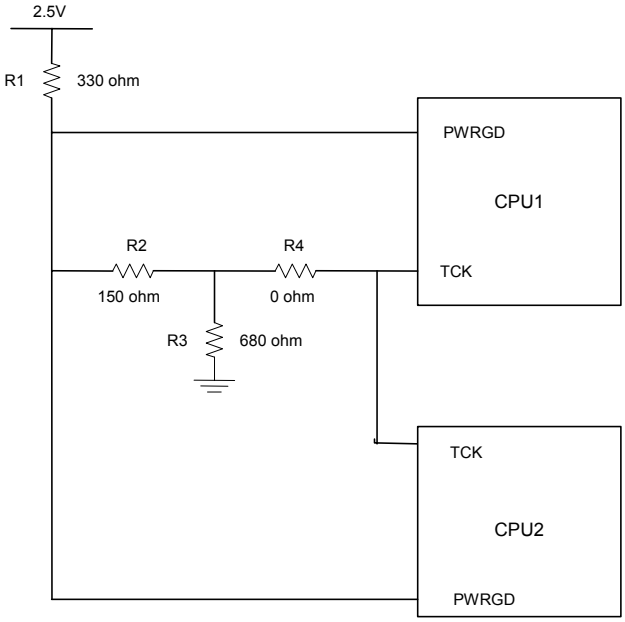
Problem: The internal control register bit responsible for operation of the Thermtrip circuit functionality may power up in a non-initialized state. As a result, THERMTRIP# may be incorrectly asserted during de-assertion of RESET# at nominal operating temperatures. When THERMTRIP# is asserted as a result of this erratum, the processor may shut down internally and stop execution but in few cases continue to execute.

Implication: This issue can lead to intermittent system power-on boot failures. The occurrence and repeatability of failures is system dependent, however all systems and processors are susceptible to failure. In addition, the processor may fail to stop execution during the event of a valid THERMTRIP# assertion resulting in the potential for permanent processor damage.

Workaround: To prevent the risk of power-on boot failures or catastrophic thermal failures, a platform workaround is required. The system must provide a rising edge on the TCK signal during the power-on sequence that meets all of the following requirements:

- Rising edge occurs after Vcc_core is valid and stable
- Rising edge occurs before or at the de-assertion of RESET#
- Rising edge occurs after all Vref input signals are at valid voltage levels
- TCK input meets the Vih min and max spec as mentioned in EMTS
